# Manhole Inspection Summary

Manhole # S33MM\_051MH

**Inspection** ☐ Is Incomplete Rating: **3) Fair**

**Location** Address: **2114 SAINT PAUL ST**

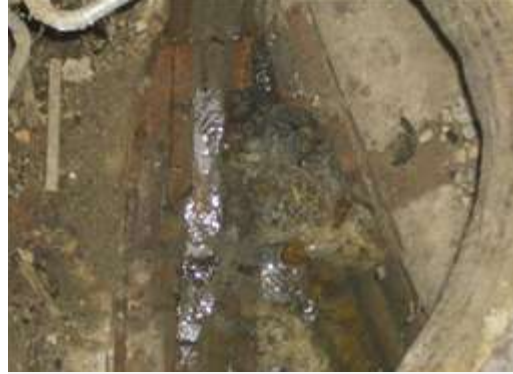
Top View

☐ Parged ☒ **Debris** (not Condition related)

Condition: ☐ Sound ☐ Cracked ☐ Root Intrusion ☐ Deteriorated ☐ Leaks ☒ **Debris**

Bench and Channel debris.

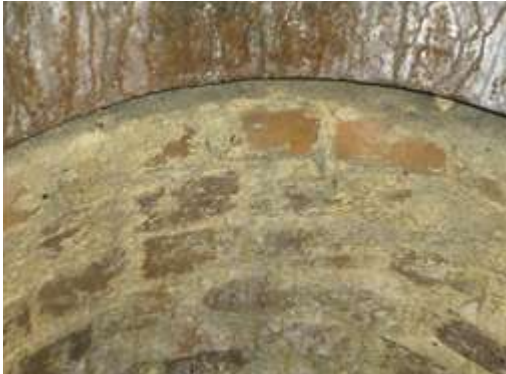
Defect

☒ **Leaks**

Infiltration: ☐ None ☒ **Joint** ☐ Cracks ☐ Mortar ☐ Roots ☒ **Wall**

Adjustment infiltration.

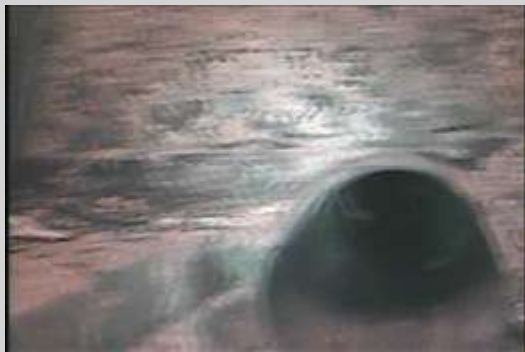
### 8 in. Circular Gravity Sewer Pipe Out @ 12 O'Clock

Deposits: ☒ None ☐ Mud ☐ Sludge ☐ Debris ☐ Grease

Infiltration: **None** Pipe Seal Cond: **Unknown**

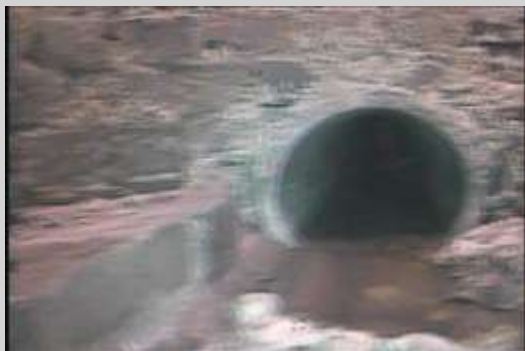
### 8 in. Circular Gravity Sewer Pipe In @ 5 O'Clock

Deposits: ☐ None ☒ **Mud** ☐ Sludge ☒ **Debris** ☐ Grease

Silt Depth: **0** (in.) Deposits Extent: **Light**

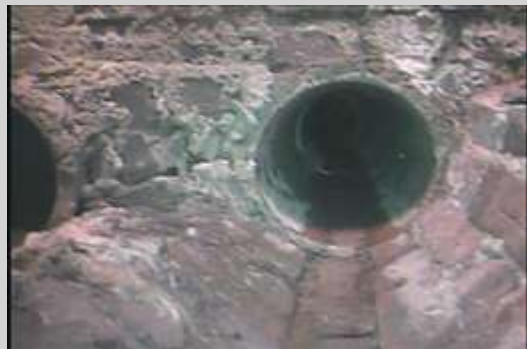
Pipe In @ 6 O'Clock

Deposits: ☒ None ☐ Mud ☐ Sludge ☐ Debris ☐ Grease

Infiltration: **None**
